**BEV PIONEERING PARTNERSHIP AT BORDEN
– CELEBRATE THE WINS, FACE THE
CHALLENGES...TOGETHER**

MDEC 2019.10.09

Incident Summary

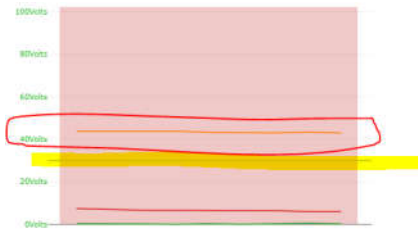
Have These Provisions Worked?

Early formation of isolation faults from internal coolant leaks have been found using the enhanced VMS program

Response plan is able to safely service the vehicle and return it to operation within 1 shift

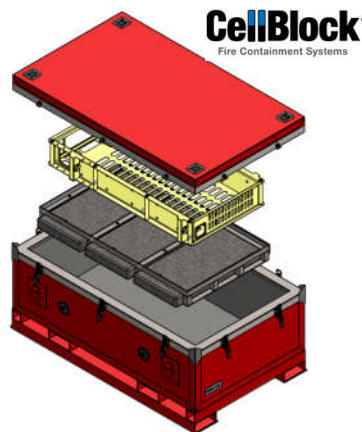
Other Initiatives Battery Safety Containers

In cases where a battery is considered at risk for transportation it should be placed into a properly designed safety container

OEMs of such containers are already constructing these for the EV automotive industry
